618-10 Burial Ground Remediation Progress Update

Bryan Foley
Richland Operations Office

RICHLAND
OPERATIONS OFFICE
United States Department of Energy

February 9, 2016

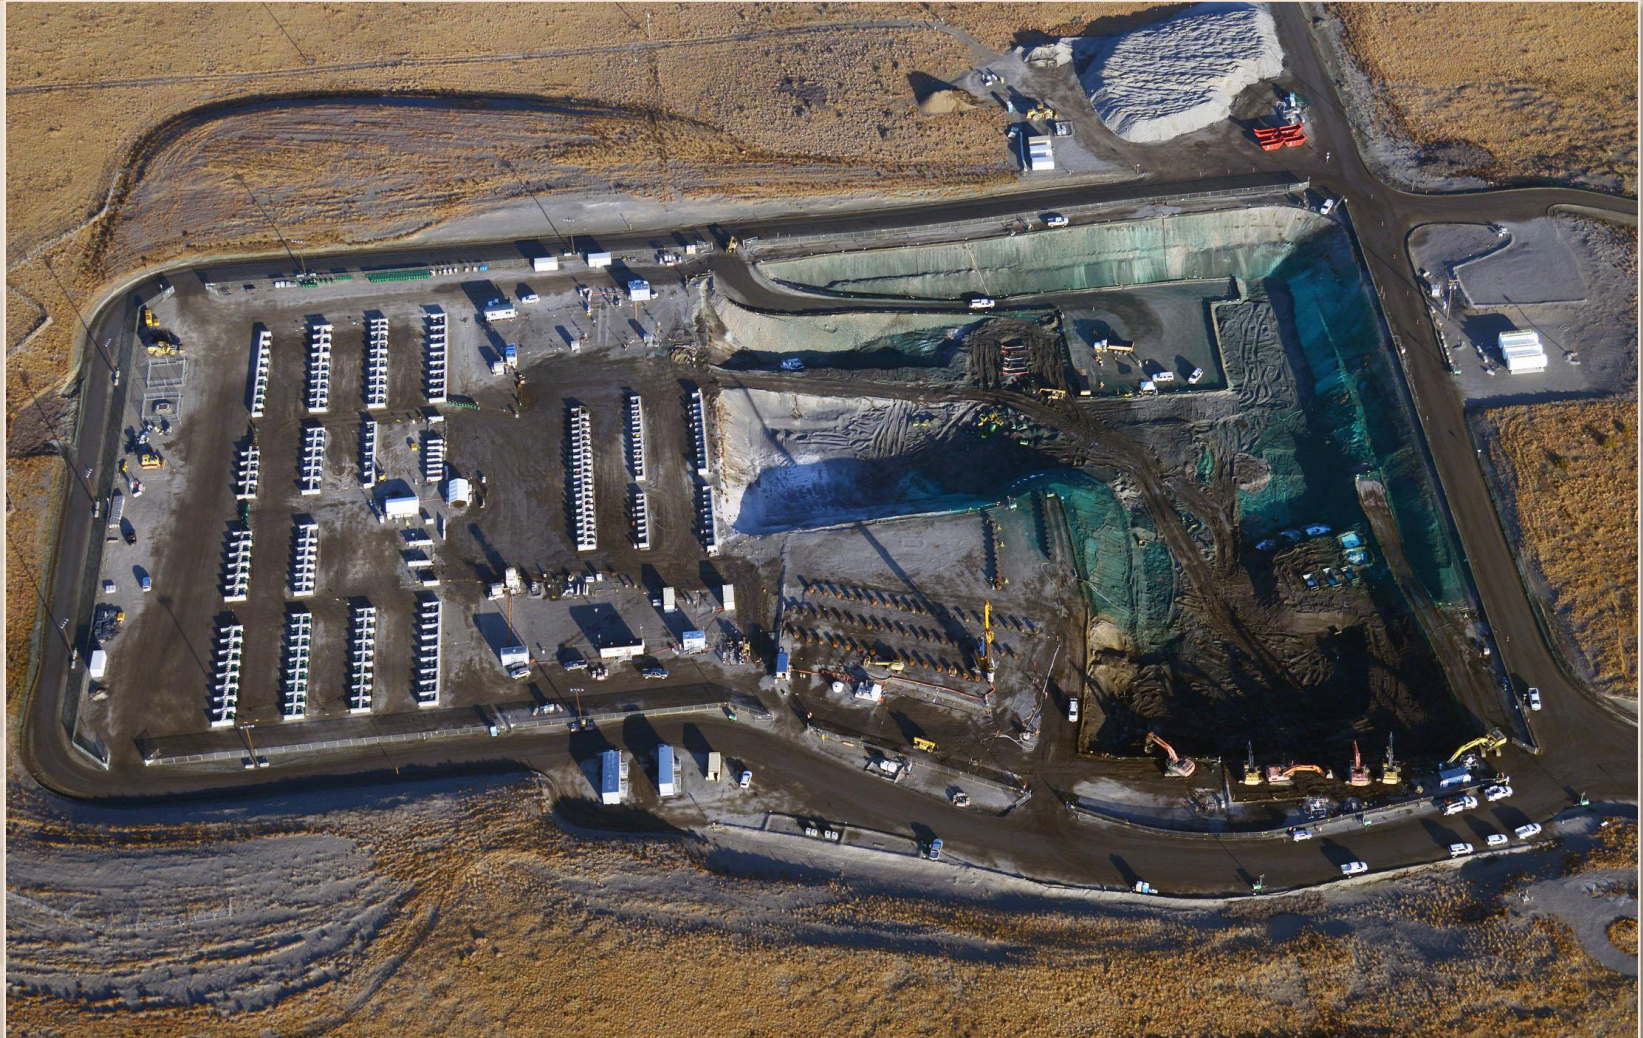
Aerial View of 618-10 Burial Ground

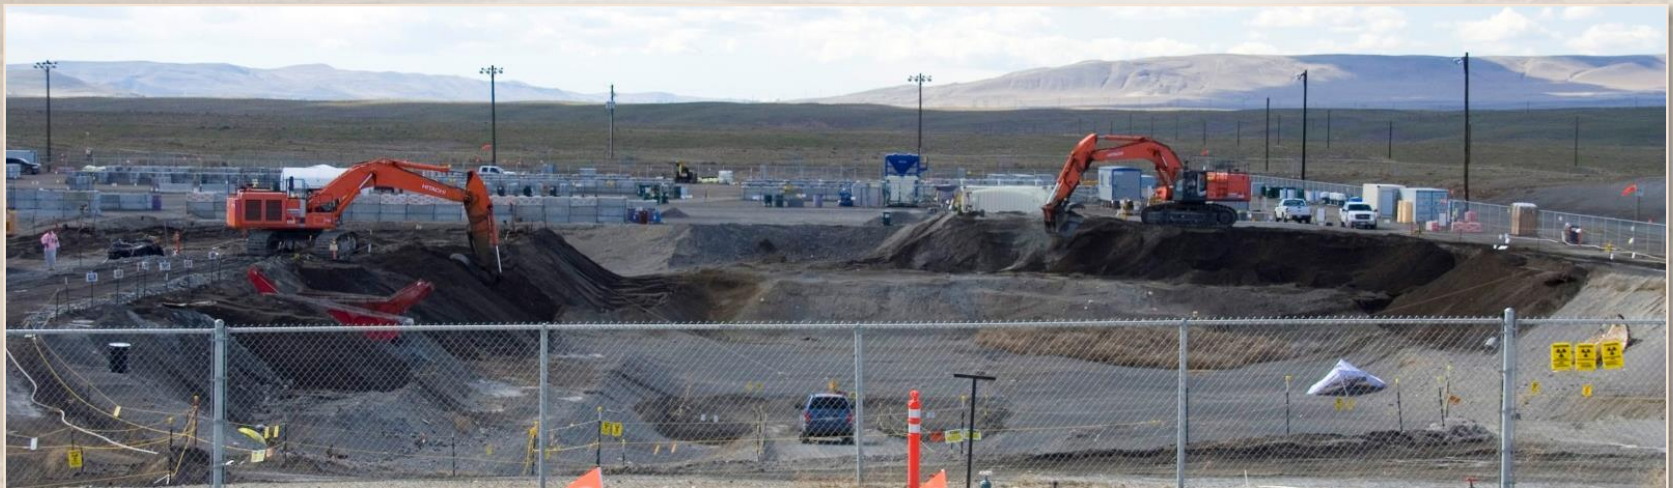
- Approximately 1,600 drums retrieved. Several hundred drums remain; estimate based on ground-penetrating radar (GPR) and field observations
- Shipped more than 321,229 tons of material to the Environmental Restoration Disposal Facility (ERDF)
- Concrete-shielded waste drums containing high dose items are being processed in grout in trenches at 618-10

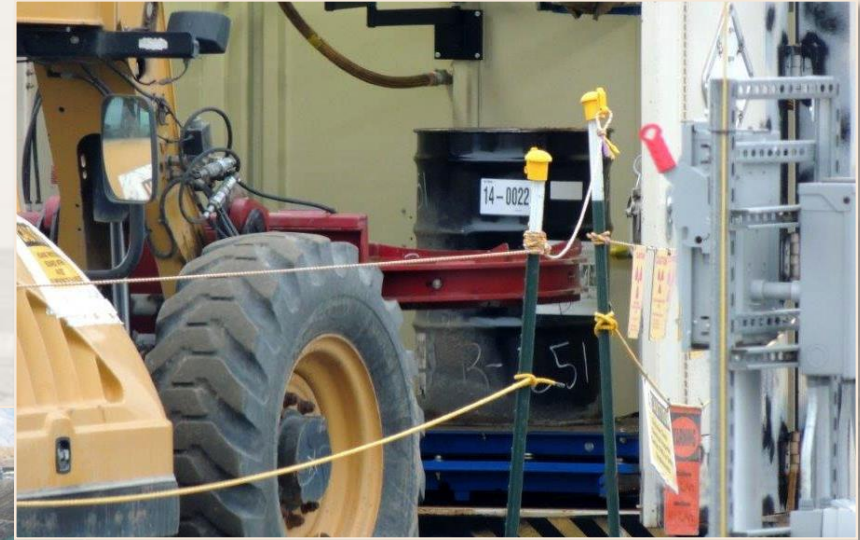
A drum punch facility is used to evaluate excavated drums

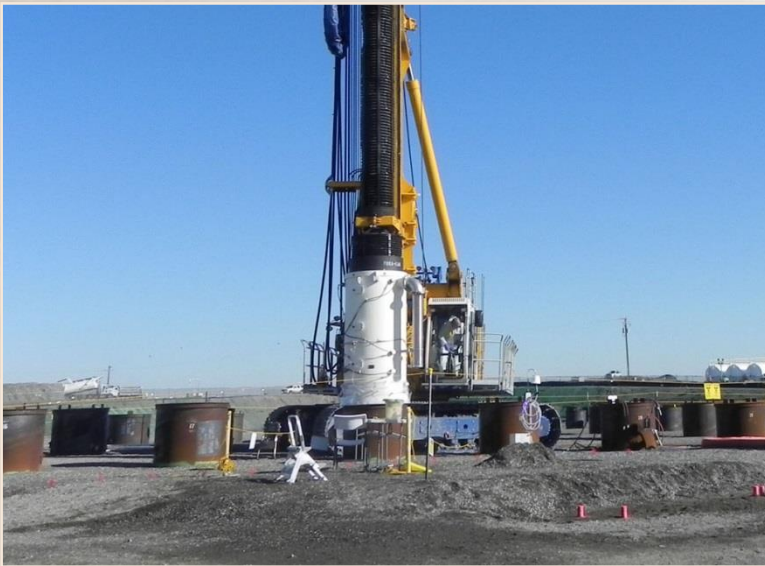
VPU auger assembly among installed over-casings

- 94 VPUs; three discovered designs
- 80 over-casings installed last spring
- Method testing and mock-up drills completed; augering began September 28
- Washington Closure Hanford's (WCH) VPU scope includes augering material in 28 over-casings and retrieving 15

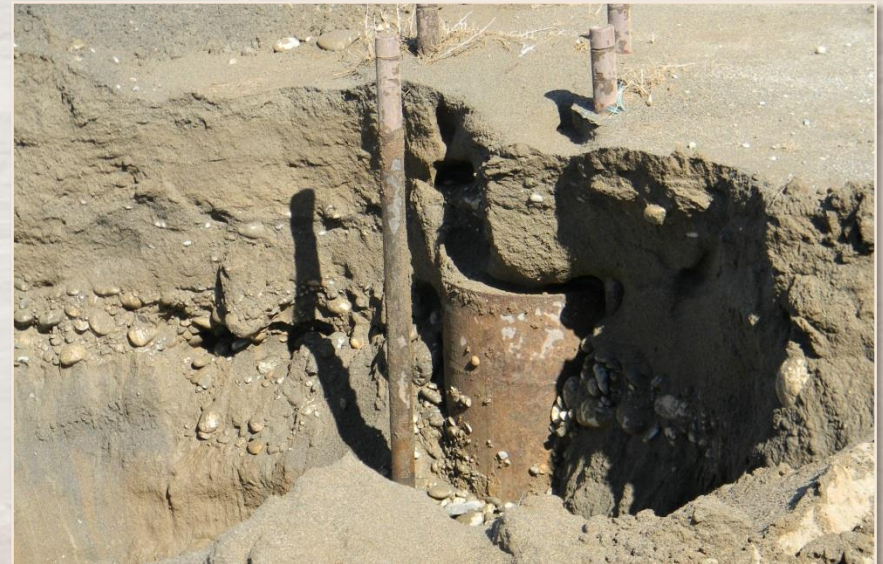
VPU variant identification activity (potholing) was done to identify/verify the type of material used in the construction of VPUs and to verify their locations
